## **An Assessment of Gully Erosion in Dutse Sahelian Zone of Jigawa State, Nigeria, and its Adverse Consequencies on the Socio-Economic Development of the State**

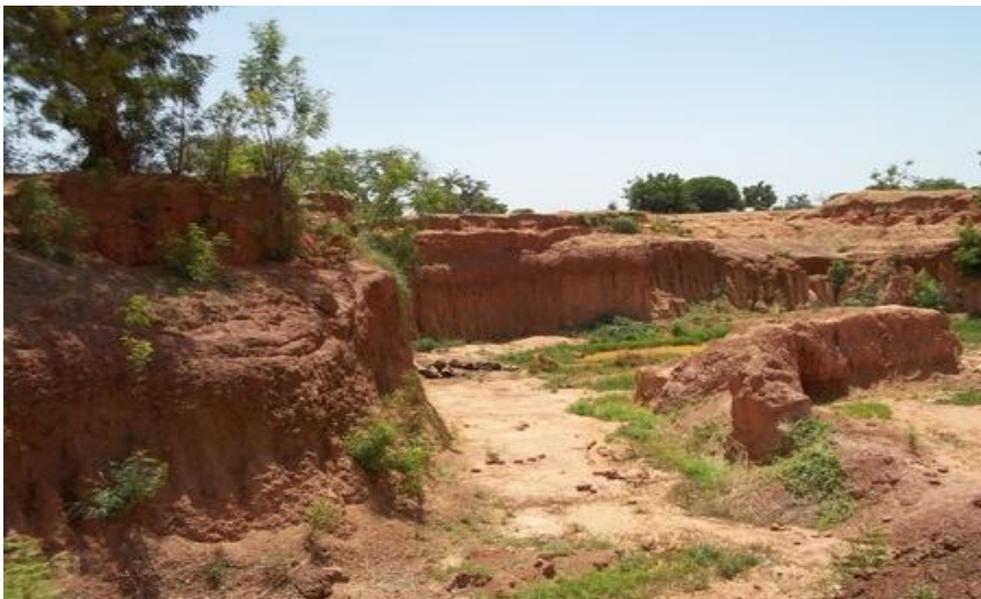
**Figure 1: Gully Erosion Showing Slumping of Soil due to Water Flow**

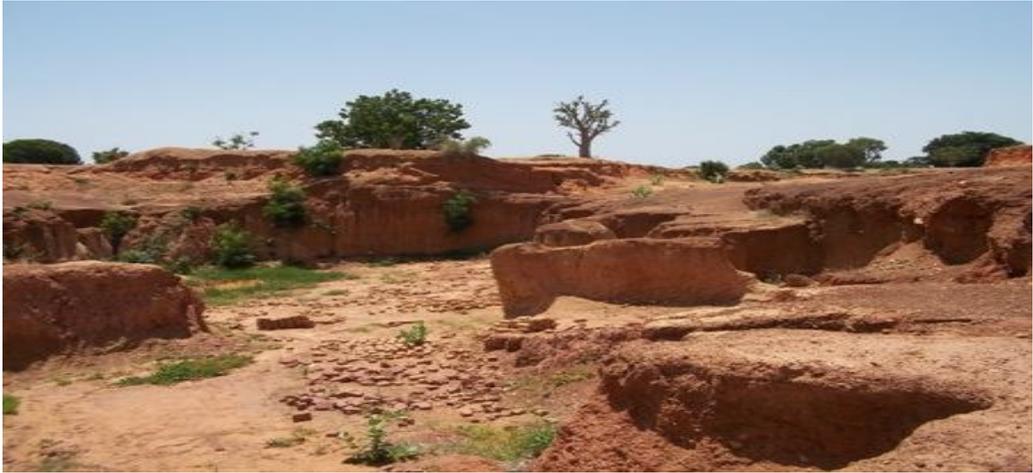
**Figure 2: Gully Erosion Showing Rubble from Washed Out Portion Showing Narrow Section with Trees Left Standing. Had the Heavy down Pour Continued, This Portion Would also have been Washed Out**
